TiO₂ Photocatalyst Treated Building

Toyohashi
Building, Japan

Photocatalyst TiO₂
Treatment was done
5-1/2 years ago

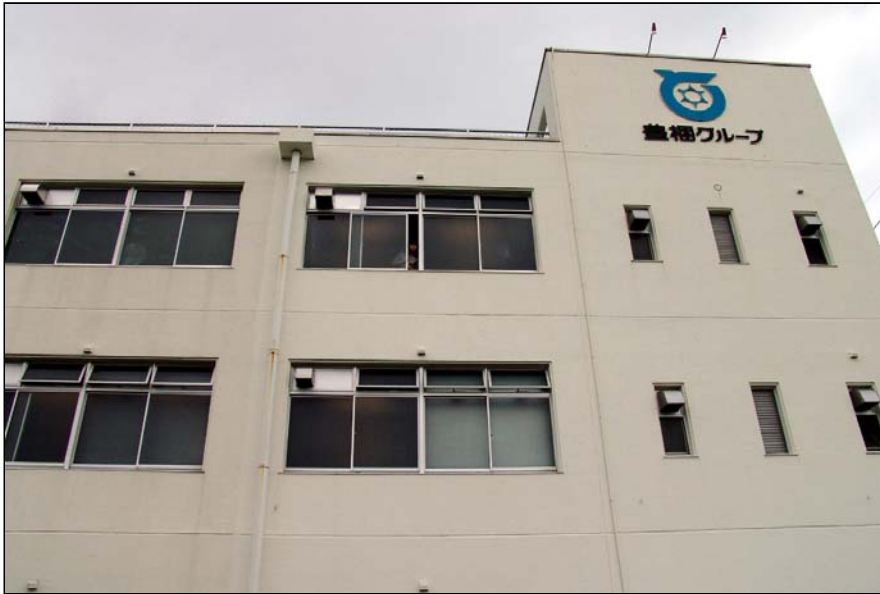
Only front half
(right side) of the
building was treated.

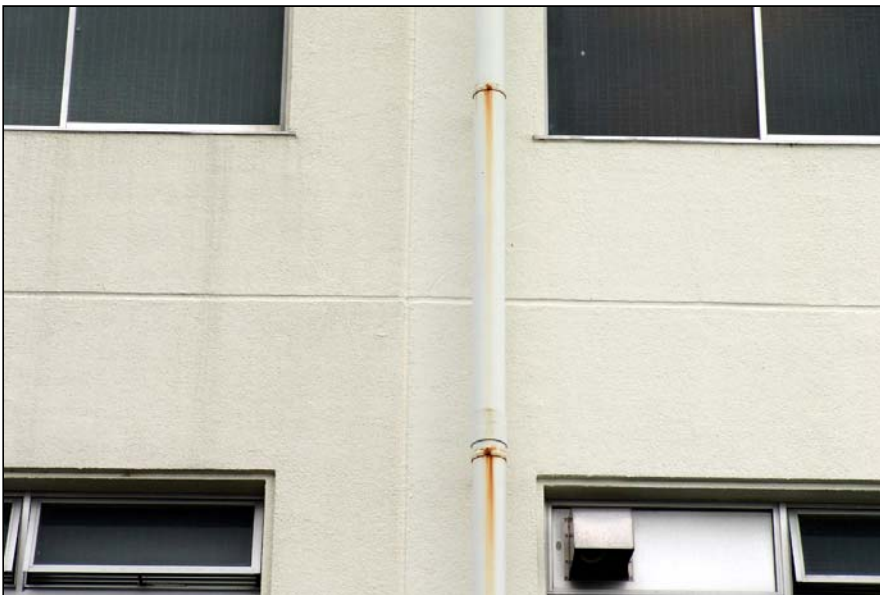
Close up of building wall
shows the
effectiveness of the
reduction in pollutants
that condense on the
walls and the mold
that's growing under
the window ledge on
the untreated walls.

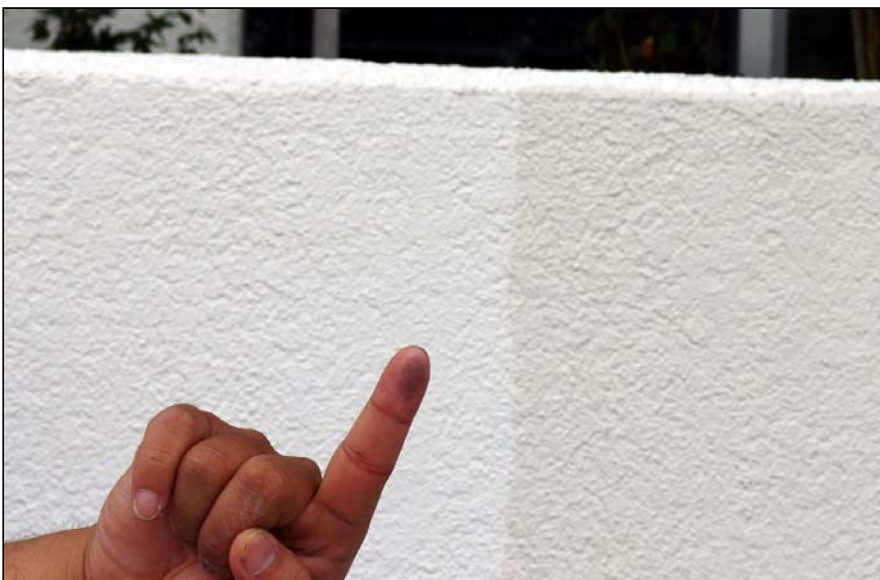
Front wall is very close
to a high traffic
highway, and only the
left half of the wall
was treated.

Wipe test showing the
pollution & dirt that's
on the un-treated side
of the front wall.
