Abatement by Encasement:
Safeguarding People
while Saving Money®

Mold Remediation & Photocatalytic Coating Application at Eon Labs

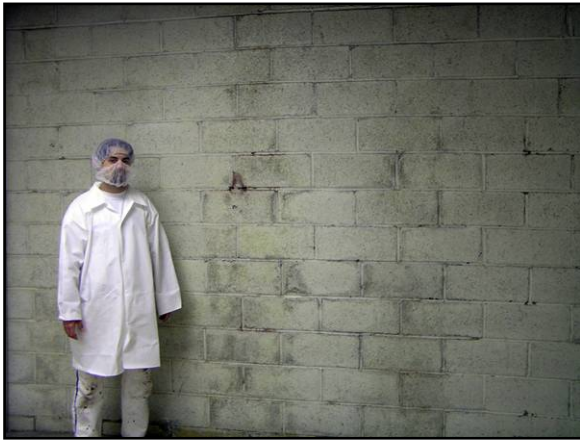
The Challenge: An outside wall, which was part of the laboratory wall inside of Eon Labs, had shown mold growth and severe discoloration. This was unacceptable for any lab as spores could circulate in the air and contaminate experiments or items used in their work environment.

The Solution: The wall was cleaned with a biocidal cleaner and allowed to dry. The Safe Encasement SE-110 and SE 130MR were chosen for both their properties as a mold resistant and highly durable coating system. The system was then prepped for the Safe Encasement Photocatalytic Coating System. The binders in the Safe Encasement SE-130MR are organic. Since the photocatalyst reacts with anything that is organic, a priming-blocking coat is necessary. The prime coat was dry within a half hour and the Titanium Dioxide Photocatalytic finish coat was applied at approximately ½ micron DFT. This provided them with a system that is self-cleaning and will help rid the lab of any odors and bacteria by oxidation from the reaction of the photocatalyst with the existing fluorescent lighting.
